**WEIR RIVER BASIN
HINGHAM, MASSACHUSETTS**

**ACCORD POND DAM
MA 00430**

PHASE I INSPECTION REPORT NATIONAL DAM INSPECTION PROGRAM

APRIL 1979

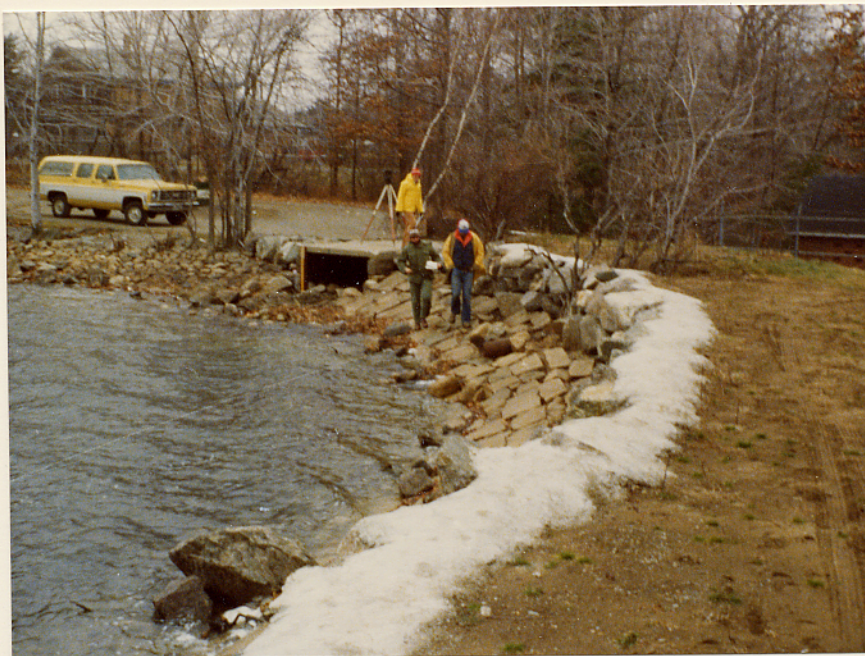
NO. 1 VIEW OF UPSTREAM SLOPE AND SPILLWAY

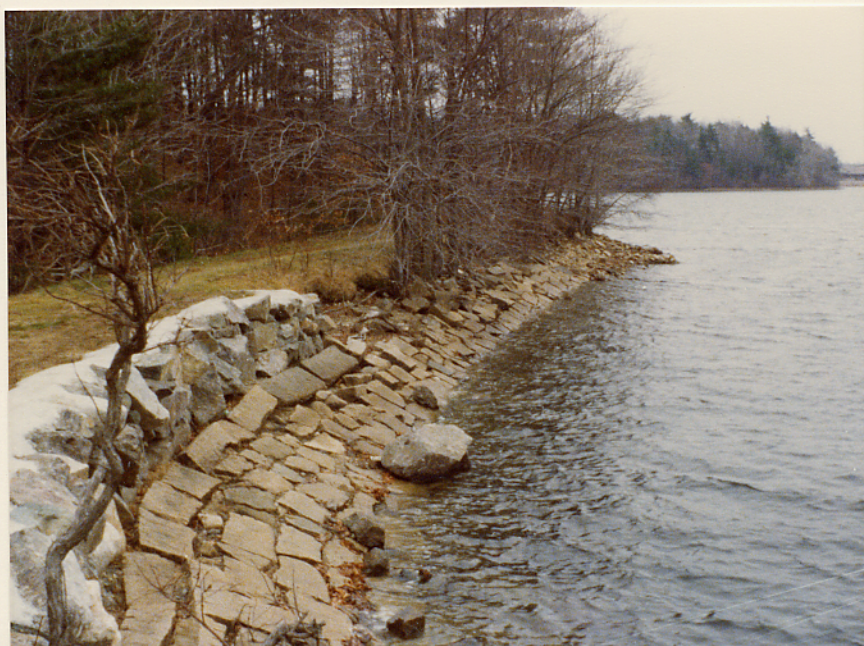
Some riprap is missing on the upstream slope of the dam to the west of the spillway. This may be due to the combined effects of trespassing and erosion. Sloughing and erosion are also visible along this entire section.

NO. 2 VIEW OF RIGHT UPSTREAM SLOPE

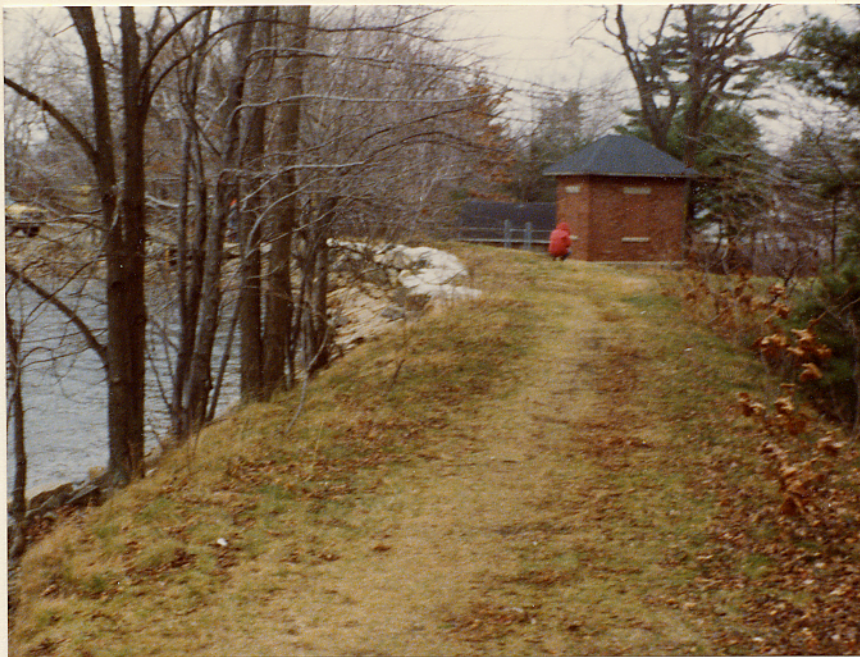
**NO. 3 CREST OF DAM AND GATEHOUSE
FROM SOUTH ABUTMENT**

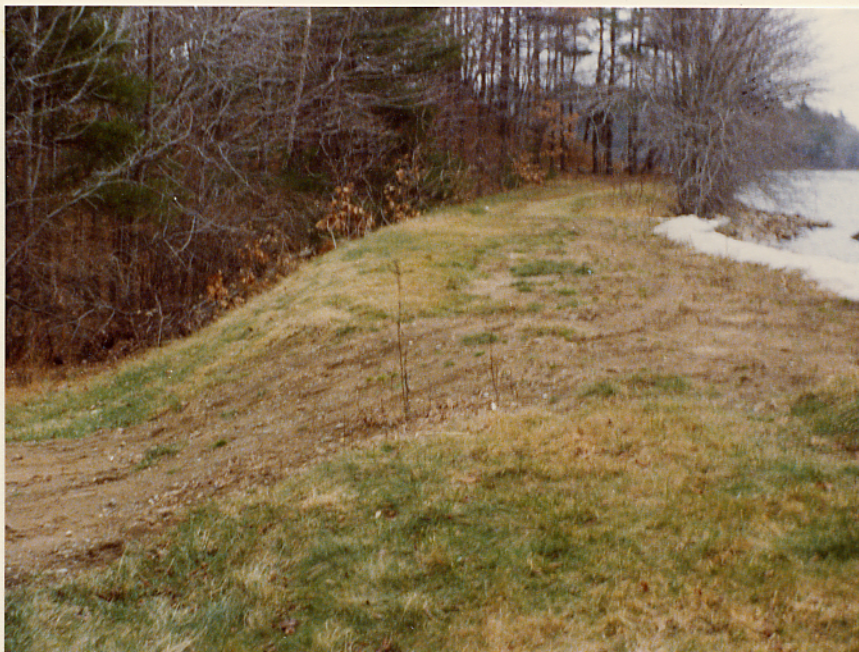
NO. 4 DOWNSTREAM SLOPE OF SOUTH ABUTMENT

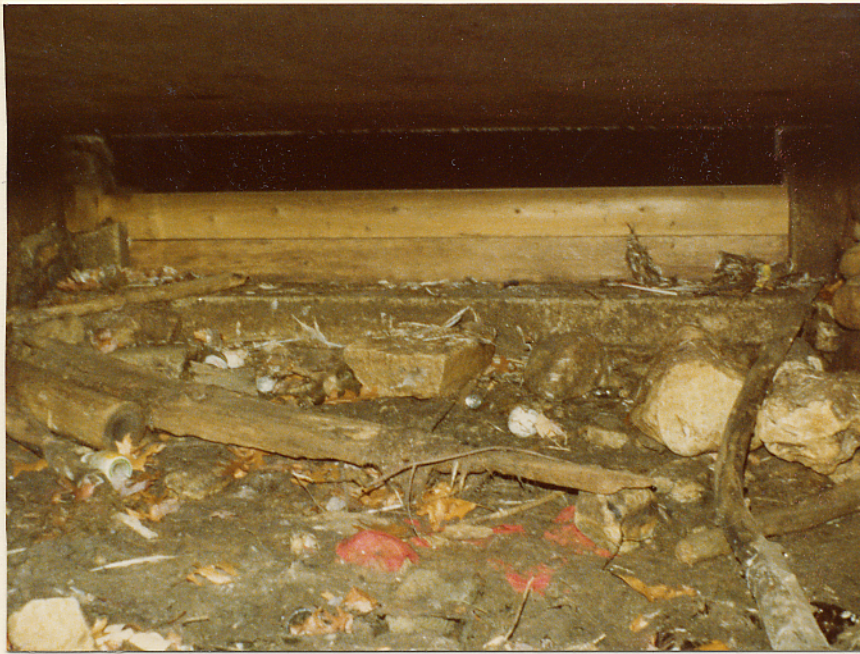
NO. 5 VIEW OF FLASHBOARDS ON SPILLWAY

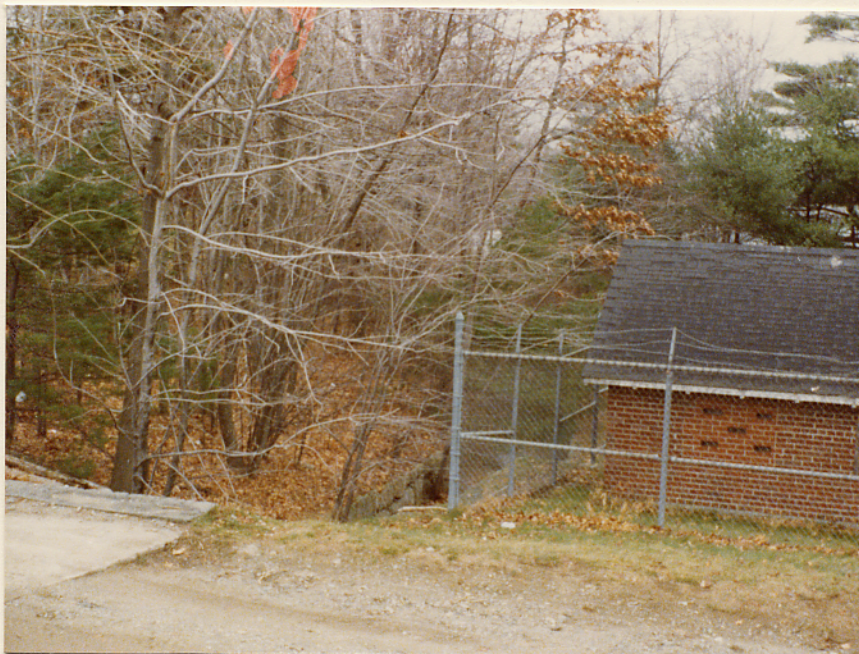
c. Discharge Channel	See attached Note 2
General Condition	See attached Note 3
Loose Rock Overhanging Channel	None
Trees Overhanging Channel	Numerous on left d/s side. Small trees in bottom.
Floor of Channel	Fair, some debris.seepage in bottom & right wall adjacent to pump house
Other Obstructions	None

**NO. 6 VIEW OF DOWNSTREAM SPILLWAY
CHANNEL AND PUMP HOUSE**

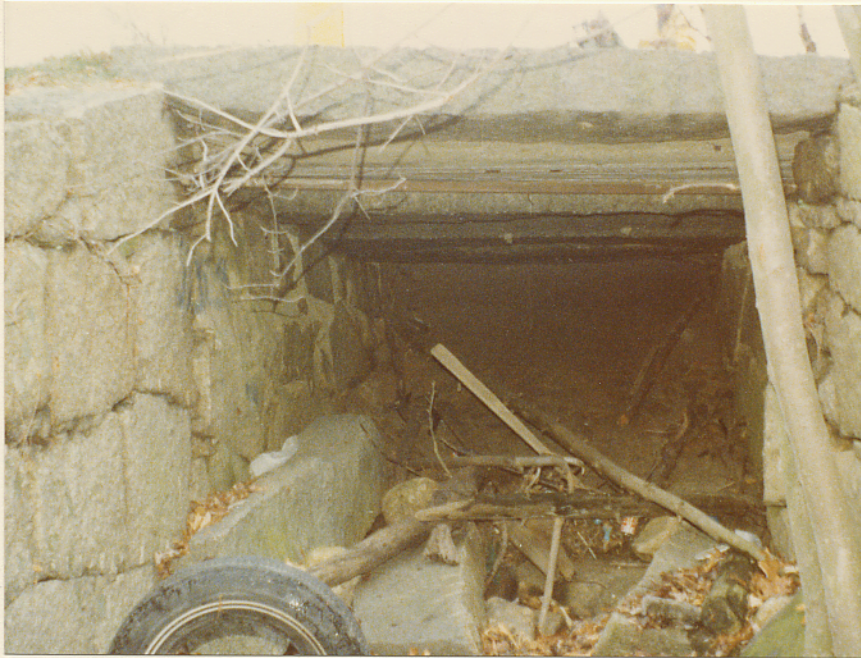
1. b. Weir and Training Walls: Walls of masonry and stone rubble capped with concrete slab-good condition.
2. c. Discharge Channel: Partially covered by concrete slab adjacent to flash boards. Open beyond.
3. General Condition: Fair to good with erosion or scour of rubble blocks at D/S toe of spillway. Some blocks dislodged. Seepage in bottom adjacent to structure.

NO. 7 VIEW OF SPILLWAY DISCHARGE CHANNEL

- (6) Repair/replace dislodged stone rubble at the toe of the spillway and in the upper portion of the discharge channel.
- (7) Clear accumulated rock and other debris from the spillway channel.

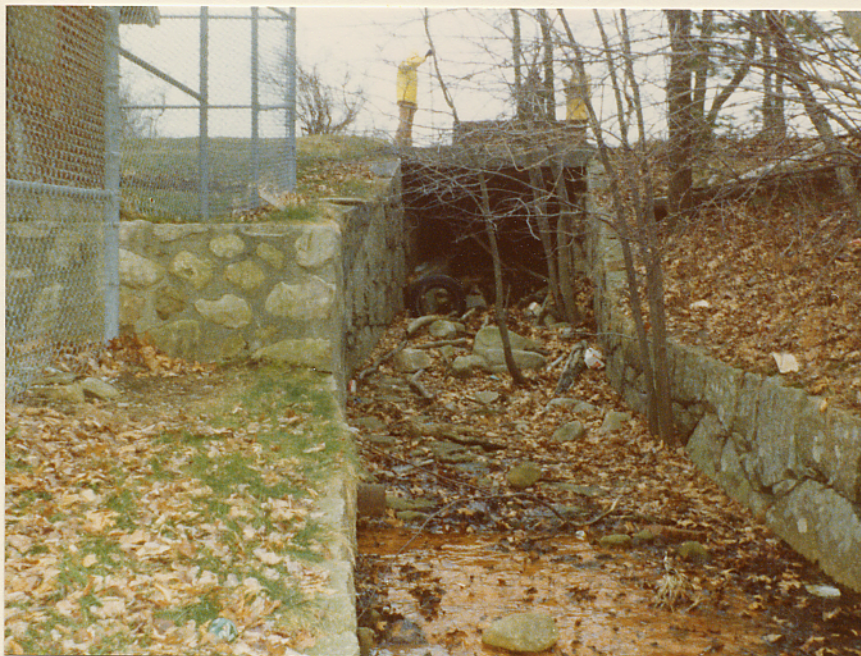
NO. 8 VIEW OF SPILLWAY DISCHARGE CHANNEL
